MEMORANDUM

Subject: 4320 Diplomacy Dr. – Roof Load Evaluation

Subject: 4320 Diplomacy Dr.– Roof Load Evaluation

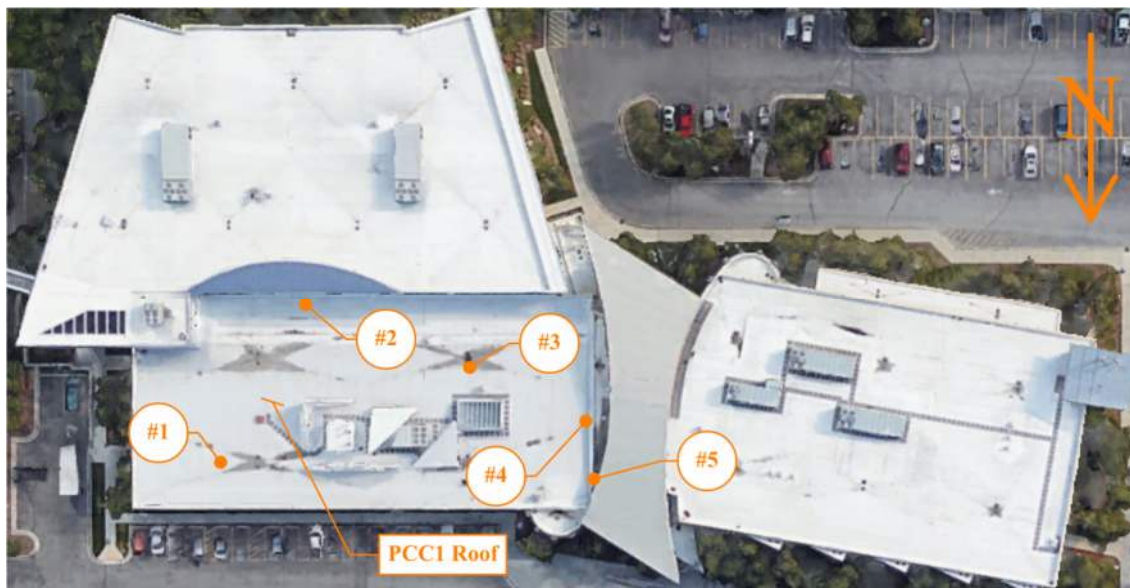
Figure 1: Aerial view of 4320 Diplomacy Drive and Locations of Measurements

One isolated area visually appeared to have snow loading greater than 40 psf (Location 5, see Figure 1). The snow at this location is dense and has iced over; as a result, we could not take a measurement. At this location, the high lobby monoslope roof is shedding snow and ice to the low roof adjacent to the west end of PCC1 (see Figure 3). Per the design drawings circa June 2002, the low roof is designed for drift; however, the west end of PCC1 was not designed for drift per the 1996 drawings.

At Location 5, remove the snow down to 2’-0” on PCC1 along its west parapet (see Figure 3 for reference); we suggest periodic checking of this location for snow spillage onto PCC1 and the snow should be removed to a depth of 2’-0”.

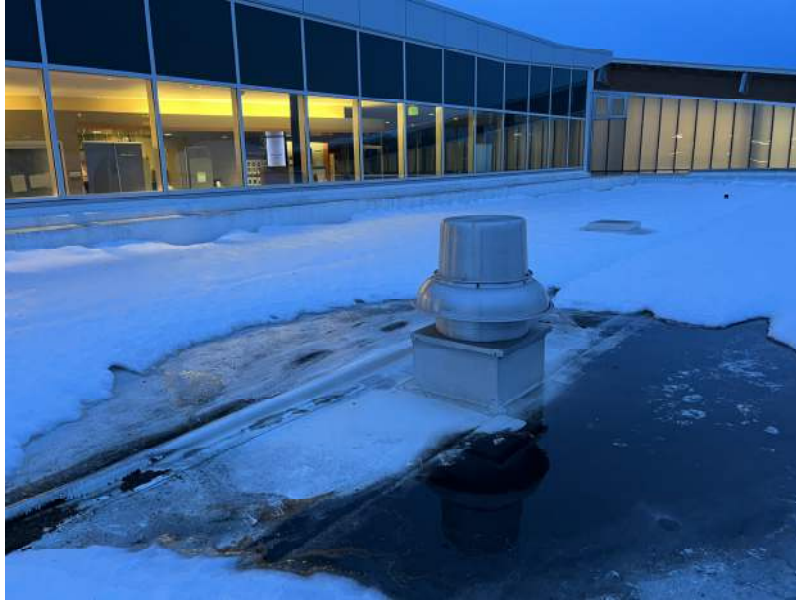
Location 3 has one inch of sitting water present likely due to melting from an adjacent exhaust fan. Sitting water appears to be widespread (see Figure 2). Other exhaust fans in the area do not appear to have a significant area of water buildup nearby.

Figure 2: Sitting Water near Exhaust Fan

Ensure roof drains remain free from ice and debris. Multiple roof drains near Location 2 had leaves building up at the drain (see Figure 4). The buildup of water at Location 3 is most likely due to a clogged drain. It is important to ensure that all roof drains remain operatable and should be periodically checked and cleared as needed.

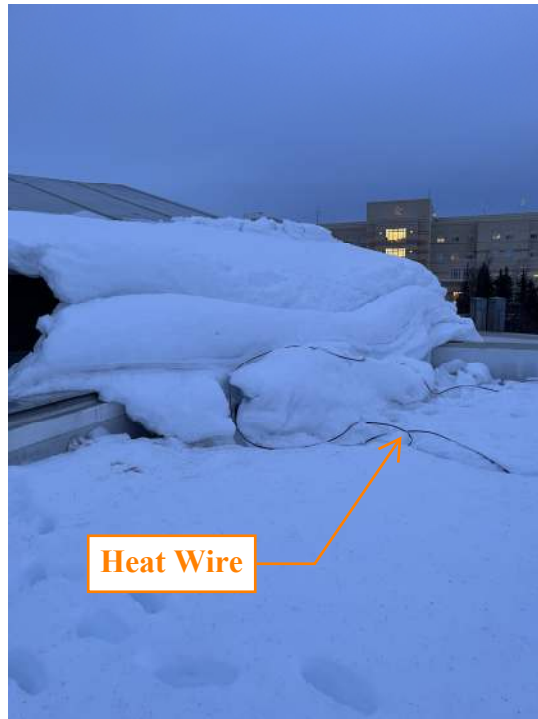
Figure 3: Sliding Snow from High Roof; Heat Wire Visible

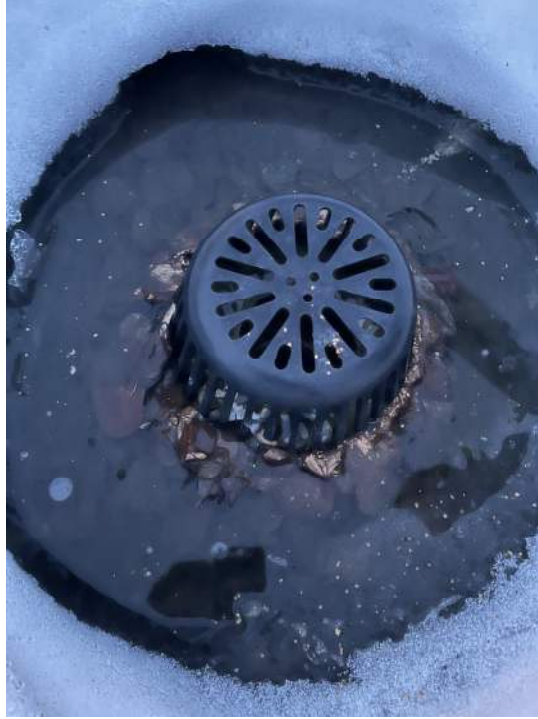
Figure 4: Drain Filled with Debris

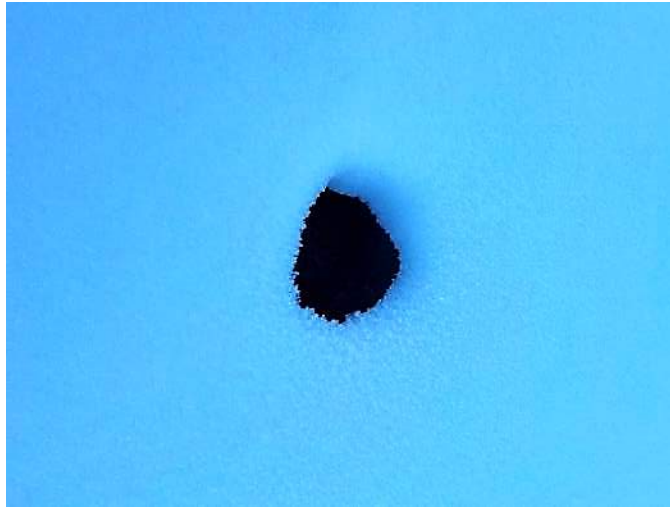
Figure 2: Roof Drain Clear of Ice Build-up.

For all locations, ensure roof drains remain free from ice. No icing of drains was observed at the time of the site visit. Given the heat transfer from the roofing, the drains should be periodically checked to ensure ice has not built up over the drains.

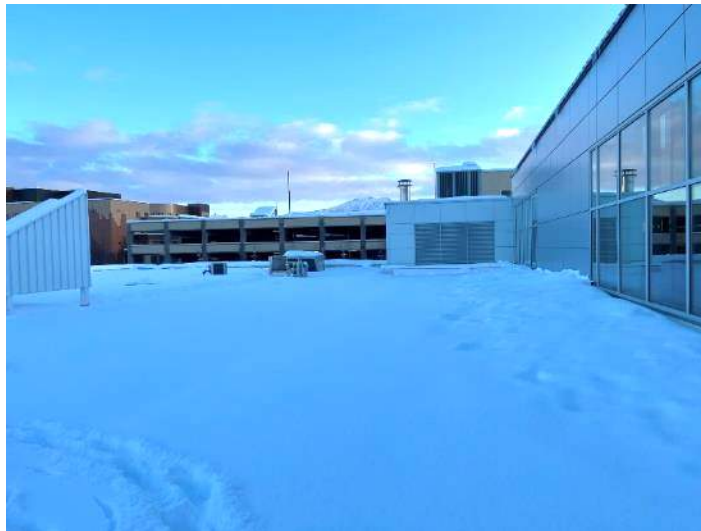
The sliding snow measured at location #3 is greater than the Municipality of Anchorage’s (MOA) minimum design roof snow load of 40 psf. Due to the steep slope of the roof directly above, the snow in this area will likely continue to build up as the year progresses.

Figure 3: Sliding Snow at Location #3.

At location #3, remove the sliding snow build-up.

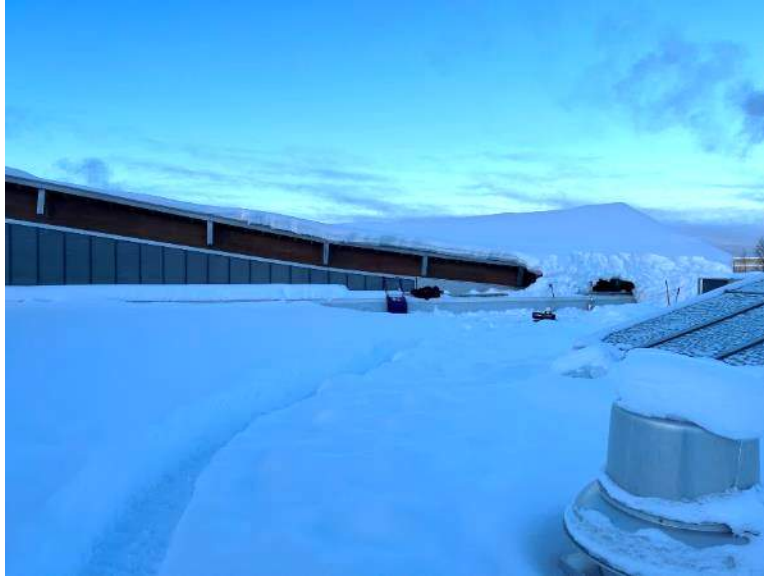
Location #5 was not measured during this effort, however the sliding snow from the upper warped roof was being removed at the time of the site visit.

Figure 4: Sliding snow at Location #5.

Continue to remove the snow from location #5 as the warped roof continues to shed snow.

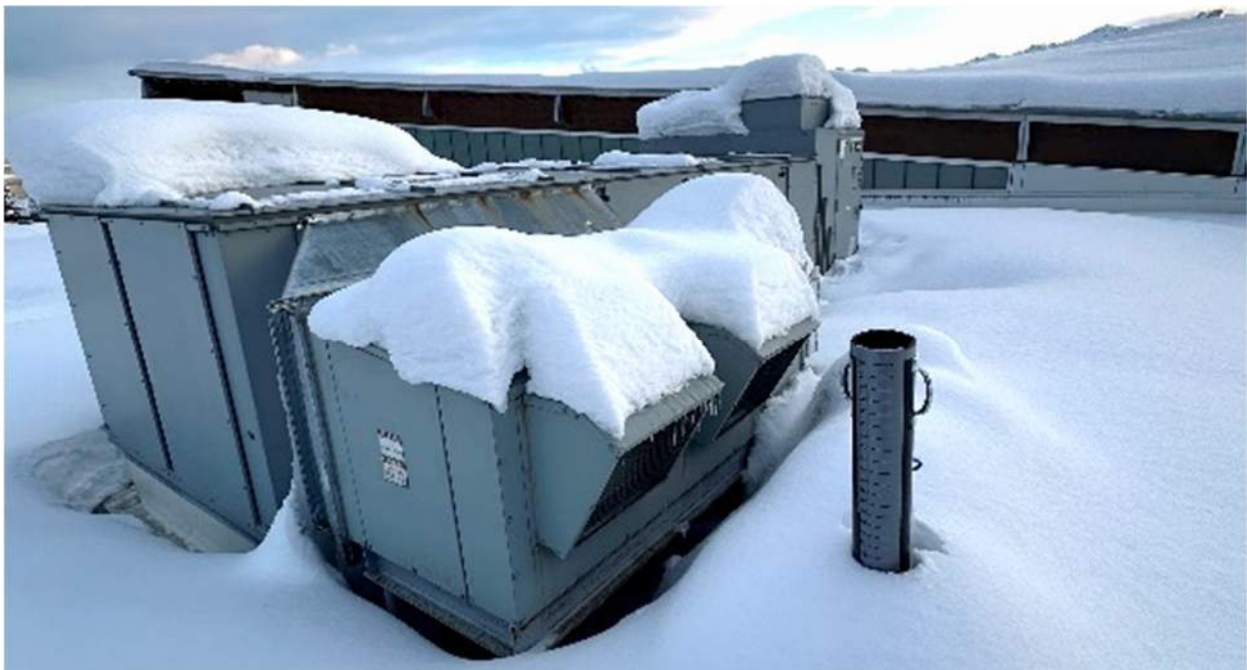
Image 1: Drifting Snow at RTU (location #3).

It is recommended that the main roofs of PCC1 and PCC2 be entirely cleared of snow.

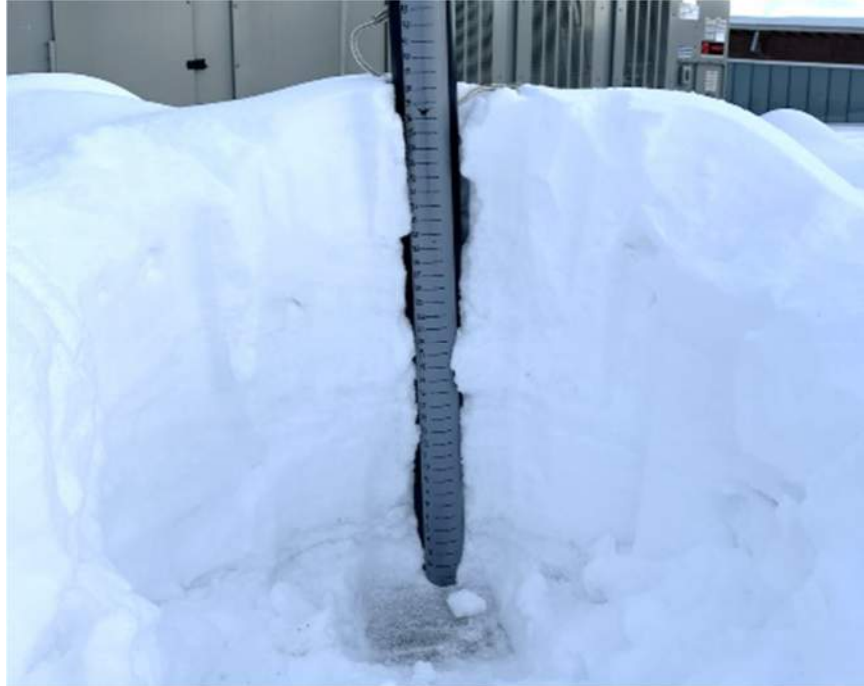
Image 2: Drifting Snow at RTU (location #4).

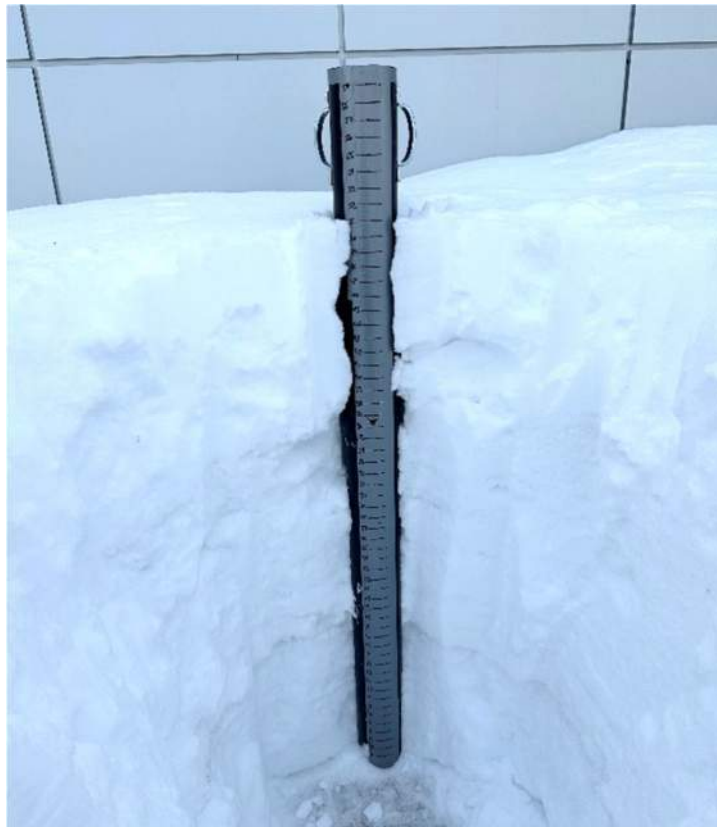
Image 3: Sliding Snow Accumulation (location #7).

Due to the steep slope of the roof directly above, the snow measured at location (7) will likely continue to build up as the year progresses and it is recommended that this area be monitored throughout the rest of the season.

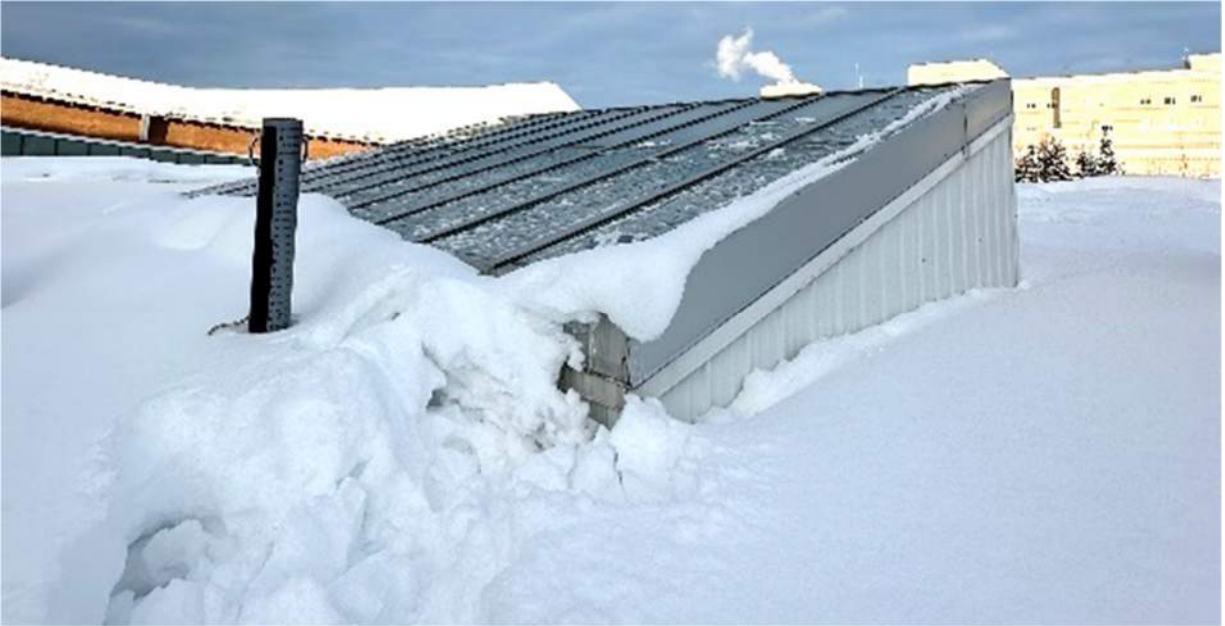
Image 4: Drifting Snow at Monoslope Skylight Feature (location #8).

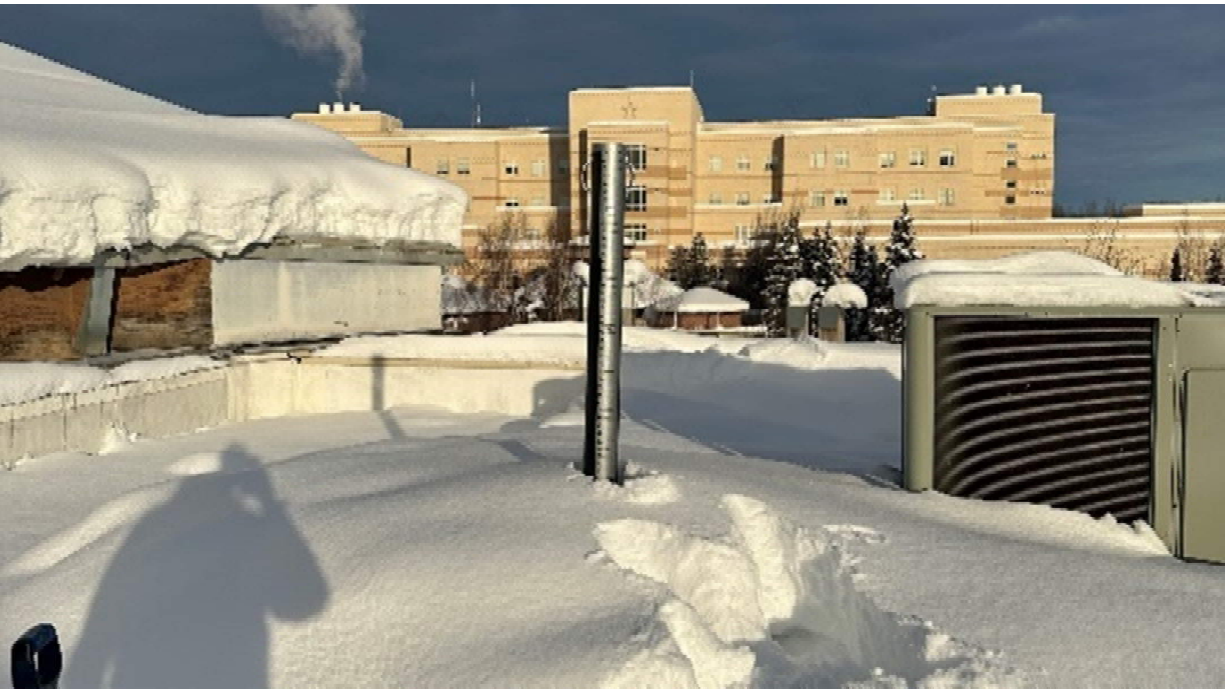
Image 5: Snow Pile Not Measured (location #9).
