MEMORANDUM

Subject: 4320 Diplomacy Dr. – Roof Load Evaluation

Subject: 4320 Diplomacy Dr.– Roof Load Evaluation

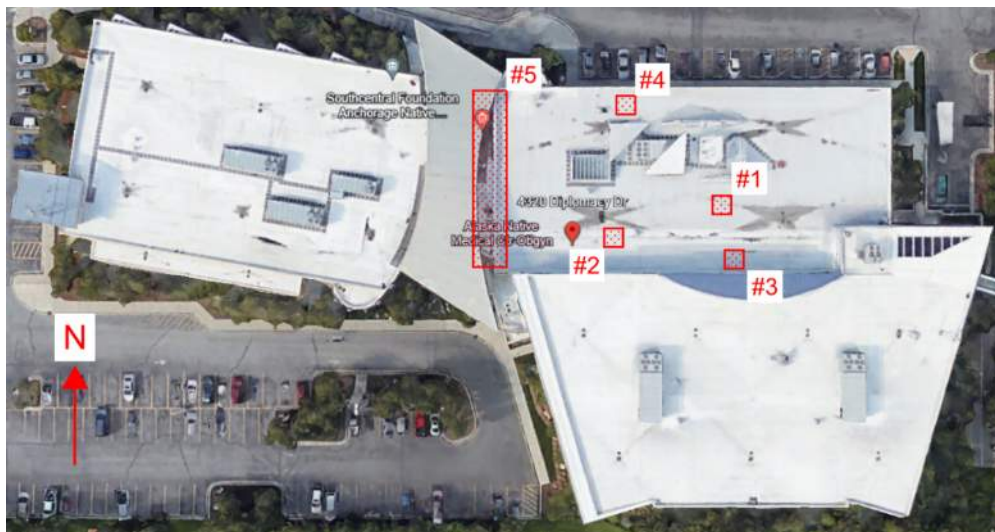
Figure 1: Aerial view of 4320 Diplomacy Dr.

Table 1 – Snow Measurement Locations				
Location	Snow Depth	Snow Density	Snow Load	Average Uniform Load
1 – Flat Roof	19 in	16.7 pcf	31.7 psf	31.1 psf*
2 – Flat Roof	23 in	15.3 pcf	29.3 psf	
3 – Sliding Snow*	44 in	17.8 pcf	65.2 psf	
4- Drift at Parapet	25 in	15.5 pcf	32.3 psf

*The average uniform snow load does not include the 65.2 psf snow load from location 3 as it is not typical of the rest of the roof

Location #5 was not measured during this effort, however the sliding snow from the upper warped roof was being removed at the time of the site visit.

Although location #1 and #4 are under design snow load, it is recommended that the roof be cleared of snow as a preventative measure against future snow events that will likely lead to snow accumulation exceeding design snow load.

For all locations, ensure roof drains remain free from ice. No icing of drains was observed at the time of the site visit. Given the heat transfer from the roofing, the drains should be periodically checked to ensure ice has not built up over the drains.

Additional snowfall accumulation will increase snow loads, and localized areas of the roof will approach or exceed the design load for roofs in Anchorage. Following a significant snow event, or a prolonged period of accumulation, it is recommended to either have the roof snow depths re-measured or have the snow removed to mitigate potential snow accumulation risks.

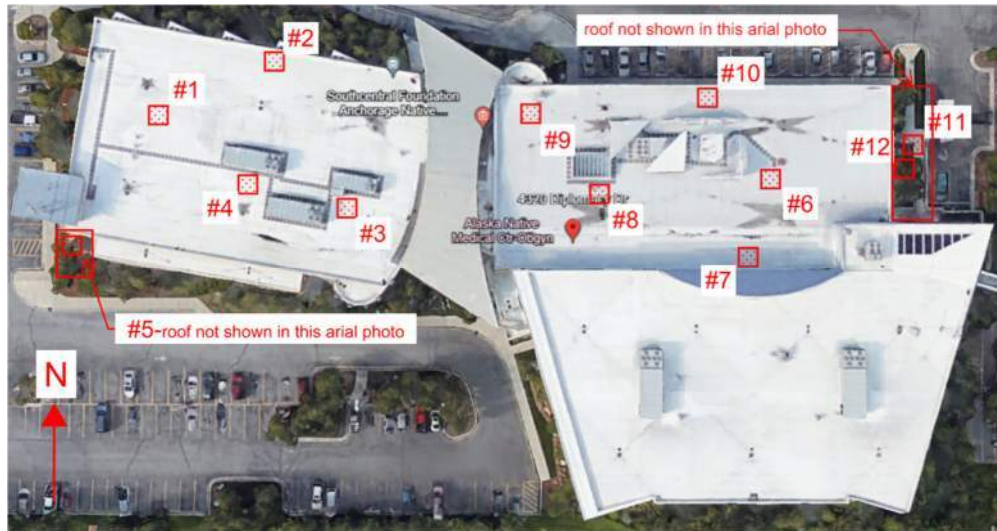
Figure 1: Aerial view of 4320 Diplomacy Dr.

Due to the steep slope of the roof directly above, the snow measured at location (7) will likely continue to build up as the year progresses and it is recommended that this area be monitored throughout the rest of the season.

It is recommended that the main roofs of PCC1 and PCC2 be entirely cleared of snow.

For all locations, ensure roof drains remain free from ice. No icing of drains was observed at the time of the site visit. Given the heat transfer from the roofing, the drains should be periodically checked to ensure ice has not built up over the drains.
